## HISTORIC BUILDING CONDITION ASSESSMENT: OBSERVATION OF THE PHYSICAL STATE OF THE BUILDING FACADE IN CHUKAI TOWN, KEMAMAN

Muhammad Afiq Wasie Mohd Asri<sup>1\*</sup> and Nor Zalina Harun<sup>1</sup>

<sup>1</sup>Institute of The Malay World and Civilization, Universiti Kebangsaan Malaysia, Malaysia

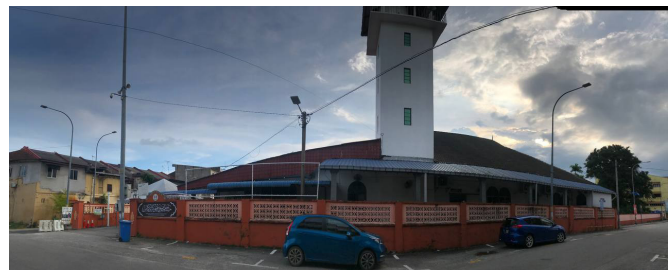
Photo 1: Jamek Mosque compound from front view

The historic building in Chukai Town which has been rated as good level of physical condition is the Jamek Mosque. The house of worship located at Jalan Masjid has visually seems to be managed with good care. This is because, externally, the façade of this building does not have any damage or serious defects. However, through observation to the mosque compound, there are also minor

A visual comparison of the façade of Jamek Mosque can be said that it has been well taken care of. In addition, it can be clearly seen that the structure and shape through the decoration of the roof and the tower are still the same. Therefore, the proof of identity of this historic building is still maintained to date. However, there are also minor defects in the appearance of the mosque, especially in the outer fence.

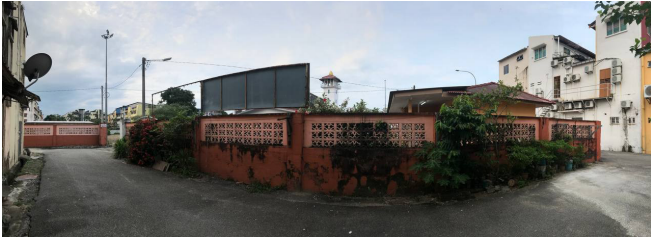
Photo 2: Jamek Mosque compound from hindsight

The defect in question is the impurities that are on the left side wall as well as the back of the mosque. There are moss-type impurities on the surface of the walls, as well as the placement of tree plants that should not be in the area around the mosque. This situation can be considered a minor flaw because it does not require any significant labour and financial resources to be resolved and can be completed in a short period of time. However, in general, the Jamek Mosque has a good level of physical condition among the historical buildings in Chukai Town.

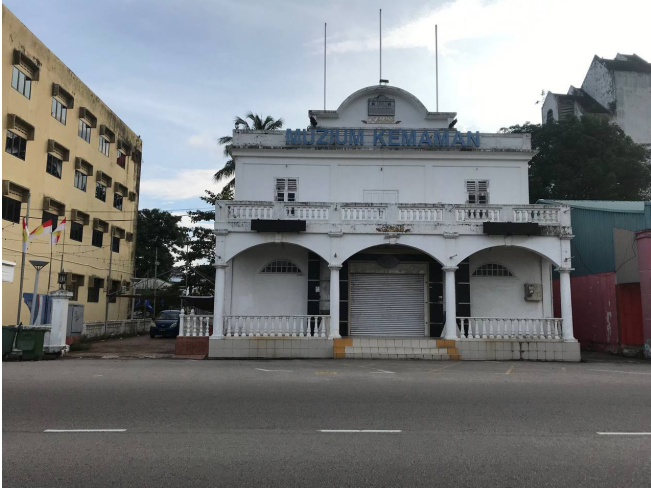
Photo 3: Kemaman Museum From Front View

From the view of the current design of this historic building, it is outwardly found that it still retains the same build shape as the original. This situation has been exhibited in the museum as one of the exhibits to show the historical development of the town and the building. It has been found that no significant changes have occurred as shown. This indicates the retention of the shape of the building despite the changing times.

It can be found that almost the entire appearance of the building has been maintained from the past until now. This includes columns, windows, stairs, balconies and the front foyer of the building. Thus, it can be concluded that the building has managed to retain its original characteristics. However, from the study of the current level of physical condition of the building, there are some defects that are considered quite serious.

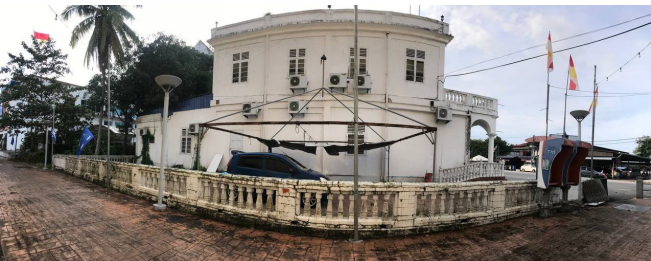
Photo 4: Kemaman Museum From Left Side View

Externally, the current situation of the Kemaman Museum is quite fibrous. Although it is recognized as one of the district museums, it is not as if it is not well maintained. The left side of the building has been tainted with things that should not be in the area. There is a rusty tent frame still placed on the grounds of the museum. In addition to a vehicle, which is likely owned by museum officials. Thus, the building is a prominent historical building with local heritage value that is upgraded as a district museum.

In addition, there is also the problem of moss and tree plants within the building area. In addition to the increase in fungus along the outer walls of the building, there are cracks to the wall. This problem can pose a greater threat of cracking or cause the stone to break. This will result in a malfunction failure of the wall which is capable of collapse.

This problem is coupled with the presence of a living tree on the cement site of the building compound and there is also a tree creeping over the building. Based on the general visual assessment guide from JKR (2013), this situation creates a messy atmosphere for the building area. Indirectly, this problem reflects the rather dirty and dull image of the building structure of the Kemaman Museum.

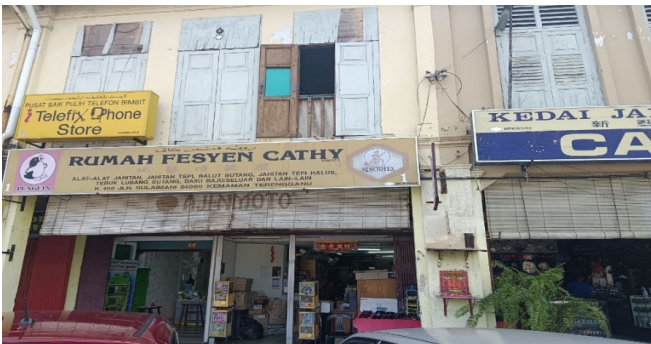
Photo 5: The window panels that have been slammed on the Jalan Sulaimani shophouse

Apart from that, in terms of window panels that are a prominent identity to the Early Straits Eclectic style, it has been found that there are several buildings that have already changed the window panels. Of the 22 eclectic shophouse buildings, only 9 still retain the original shape of the panels (lot buildings numbered 34, 35, 37, 40, 41, 42, 43, 44, and 45). The rest have modified their respective window panels. In other words, only 9 panel pieces really retain the original architectural style of this heritage.

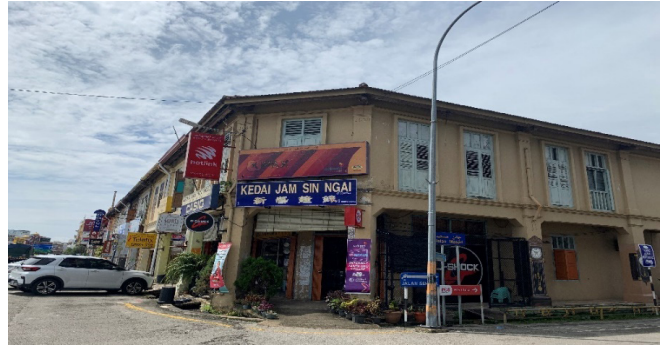
Photo 6: Obvious damage to row of window panels on Jalan Sulaimani shophouses

However, these 9 buildings have their own problems that undermine the value of the historic buildings. It has been found that the level of custodians and maintenance of this historic building still needs to be improved. This is said to be because there are components that have been damaged but not repaired, especially against the window panels. The observation also found that the window panels on lot buildings numbered 40, 41 and 42 were decayed resulting in a sloping of the windows. This needs to be addressed to prevent other components from experiencing the same problem.

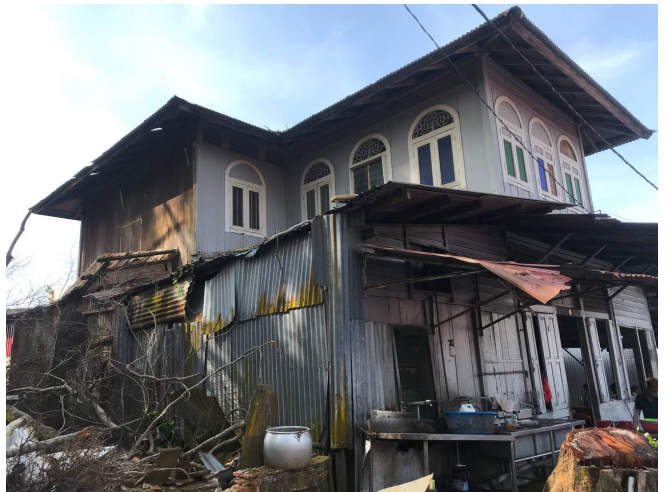
Photo 7: Rear View of Building K52

Externally, this historic building is arguably poorly maintained, although it has now turned into a coffee shop. This is said to be due to defects and damage to the external structure of the building and its surroundings. The first problem was about the roof of the building. Observations have found that the zinc roofs used in this building are already tilted bent, perforated and rusty. It can also be seen that some pieces of zinc roof have been used as a barrier to the exterior walls of the building.

In the meantime, the environment of the K52 building area is seen as dirty and fibrous. Observations of this building found that although it has a relatively large area, it is mostly filled with bushes and rubbish. There are also cluttered wooden twigs, fallen trees and rubbish-burning waste on the back of the building. Plus, there is a pile of rubbish from empty and used up oil bottles that are not well managed can be seen. The situation caused the building to be seen as quite dirty, faded, dull and lack lustre as an eatery.

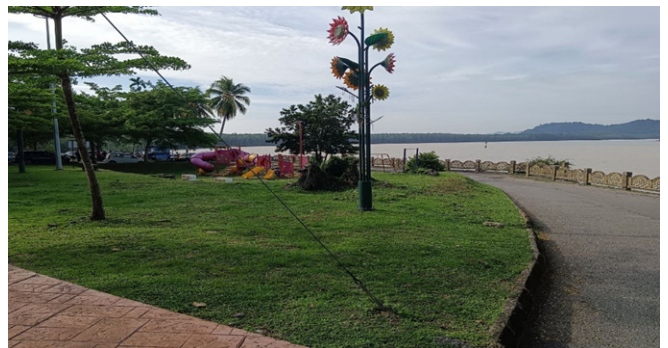
Photo 8: A playground developed on the site of a former Customs Office

The Customs Office was an important government building in the old days, especially during the rapid development of Chukai Town in the 1920s. Kemaman River is an important trade route for the economy of the area. The river was once known as the hub of iron ore transportation routes taken at *Bukit Machang Setahun* and *Bukit Kambing* (M. S. Muda, 2020). This mineral resource will be carried anchored at this port before being exported out. Thus, the customs office located next to the river serves to manage and implement the maritime taxation system. The building has been demolished and is now used as promenade called *Taman Persiaran Chukai*.
