Adaptive Reuse Implementation in Public Facilities: From Residential Use to Community Health Centers

Nurtati Soewarno^{1*}, Mustika Kusumaning Wardhani¹

¹Department of Architecture, Faculty of Architecture and Design, Institut Teknologi Nasional Bandung, Indonesia.

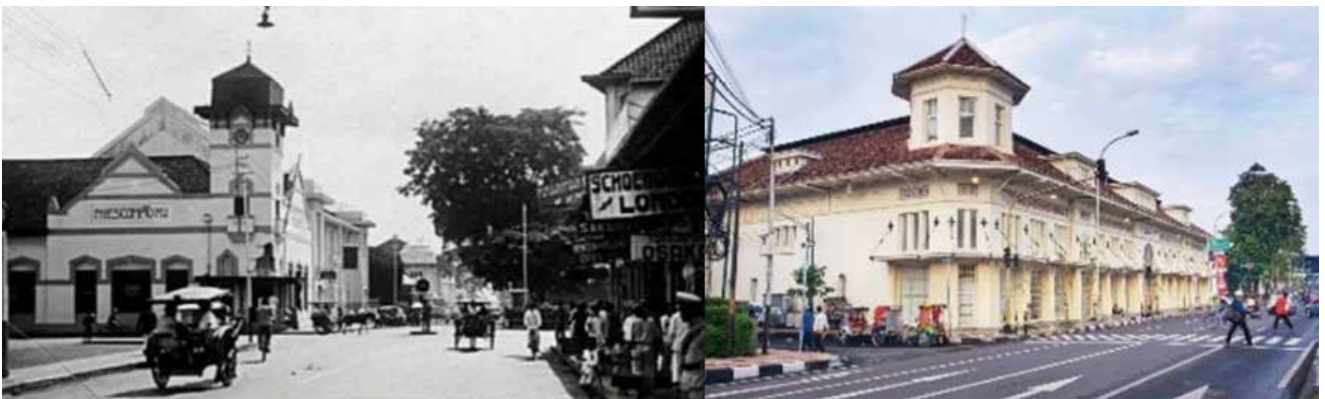
The tower of the *Nederlandsch Indische Escompo* building marks the location of the center of Bandung, to which the majority of visitors came from the direction of the capital of the Dutch East Indies (currently Jakarta). Likewise, *Warenhuus De Vries* was a supermarket that sold various necessities for Dutch people who lived on the tea plantations around Bandung. The tower on the east side of the building was made different and taller than the building itself so that it marks the location of the building from the east, the direction from which the tea plantation owners came (see Figure 2) below:

Figure 2. The single-type buildings—nonresidential: Mandiri Bank (previously Escampto Bank 1915), OCBC Bank (previously Warenhuis de Vries 1909) (Source: Wikipedia, 2024)

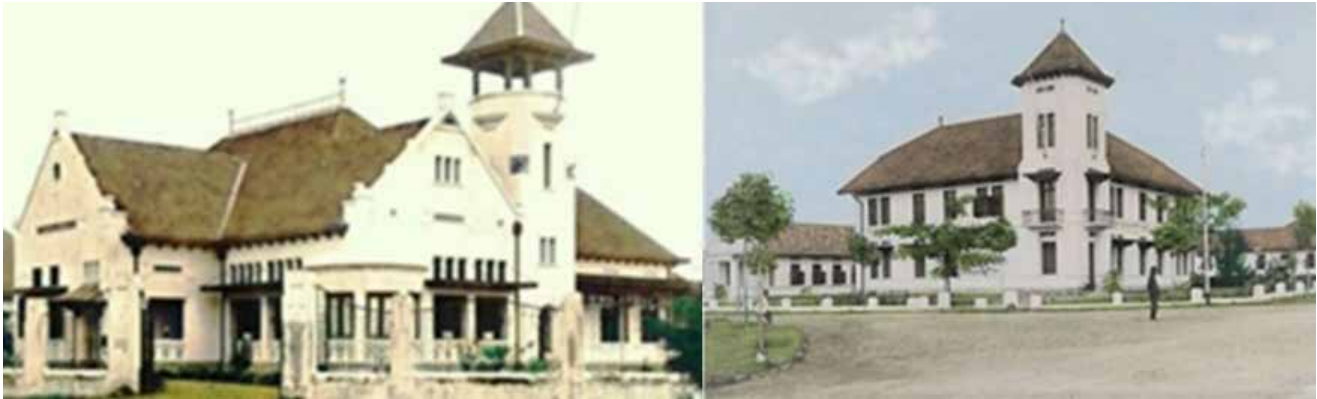
The other tower building is the Zeni (military office), which is the entrance to the military office area from the east. This building is located at the end of Java Street and faces east toward warehouses and army housing. The building tower faces northeast, so it is easy to recognize from where the Dutch people lived in the north.

Figure 3. The Salvation Army, 1894 (until present time), Kodam III Siliwangi–Zeni (military office until present time) (Source: Wikipedia, 2023)

The theory expressed by Lynch (1960) assessed the four examples of tower buildings, which show that tower buildings can become landmarks in an area and also become an identity. From the functional and visual aspects, the tower is a “focal point” at the corner of the street. This type of tower building is used for various functions, such as offices, banks, schools, hotels, and residential, and former colonial residential buildings with towers are scattered at several points in Bandung. The discourse on corner tower buildings is considered something new since this typology in Bandung has not been widely discussed in the latest scientific articles.

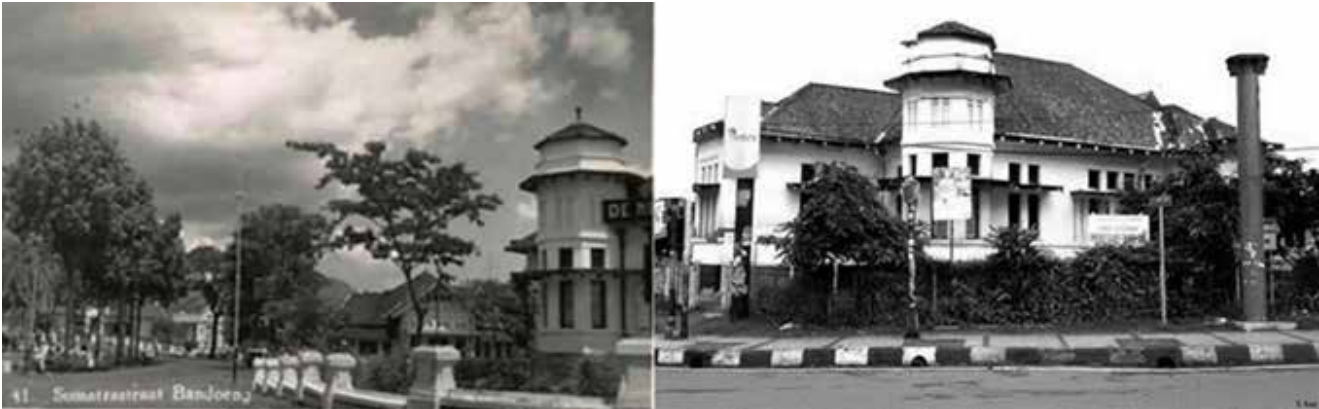
Figure 4: Previous (1930) and present front view, the hexagonal tower as a unique feature (Source: Wikipedia and Author, 2024)

The uniqueness of the hexagonal tower in this building is that it has two canopies at the top and the middle. The canopy at the top covers the air holes, while the canopy in the middle is under the ventilation (bouverlight) and covers several windows. The roof covering of the tower is a shingle roof, which is different from the main building, which is a tile roof. This is because the angle of inclination of the two is different; the angle of the tower needs to be lower, and it is not possible to use roof tiles. The tower has facing in various directions according to the shape of the tower, allowing sunlight to enter and providing air circulation. At the bottom of the canopy, vertical windows follow the tower’s various directions, as shown in Figure 4 below.

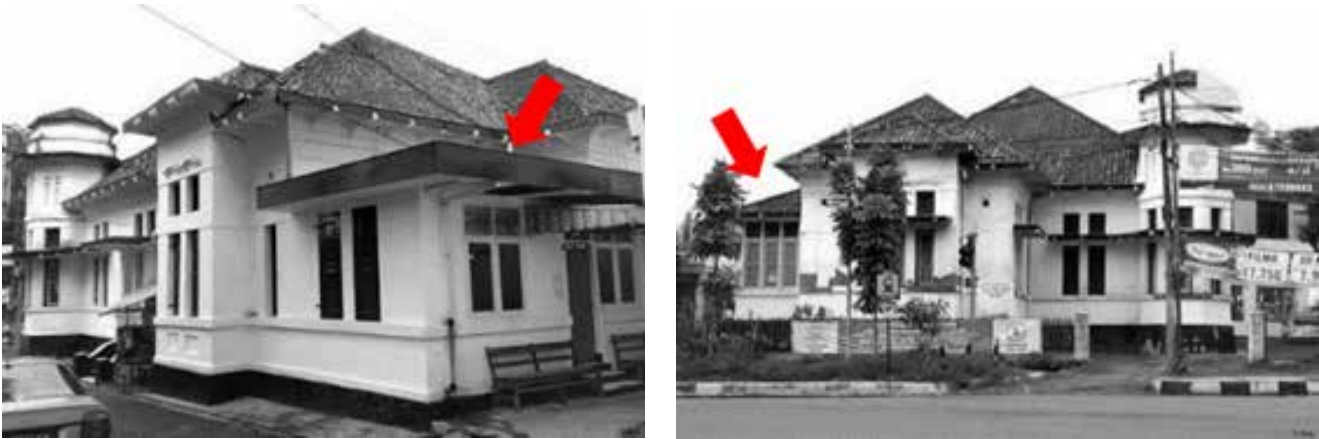
Figure 5: The additional room blocks the entry of air and sunlight (source: Author, 2024)

The parameters to be observed in this study are spatial zoning, building elements, and circulation flows before and after reuse. The first building element that will be discussed is the existence of a tower, which is a characteristic of the building. The tower as the distinctive element of the building still exists, but its function has changed. Due to limited space, the octagonal floor plan currently serves as the administration space for the emergency room. The new additional room built facing the street is not prominent, having the same color, but blocks the entry of air and sunlight to some rooms at the rear, as seen in Figure 5.

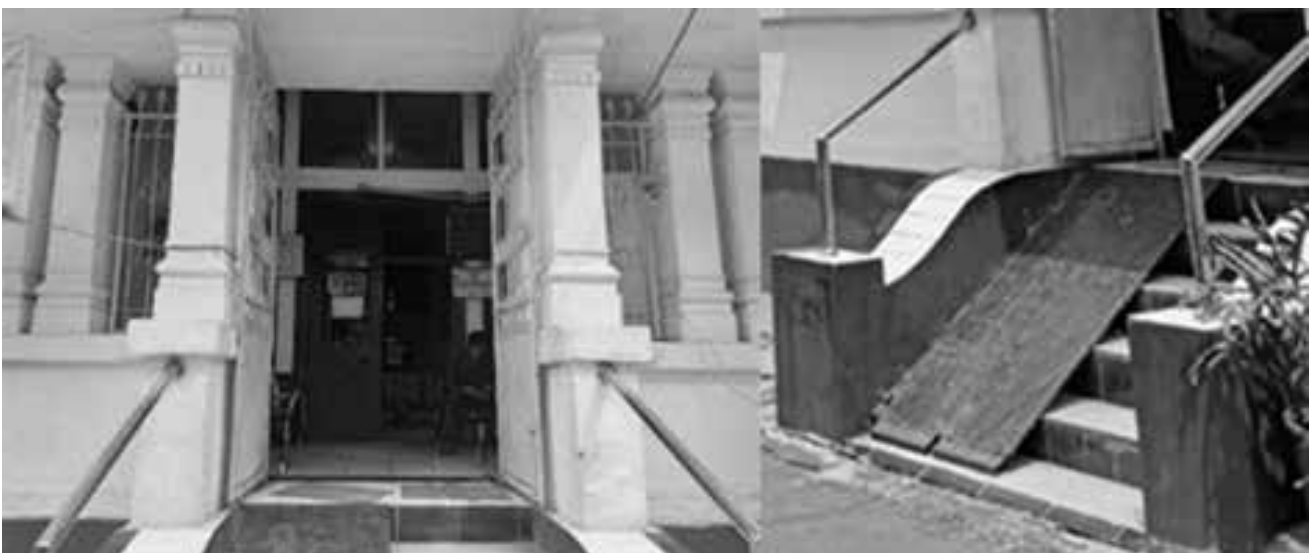
Figure 8: The Greek pillars on the front porch and the additional installation of the trellis (Source: Author, 2024)

The hexagonal tower and the Greek pillars on the front of the building reflect the Empire style influence (see Figure 8). The Tamblong CHC building was established from 1910 to 1920, transitioning from the Empire style to the modern architectural style oriented to the Netherlands. This transitional architectural style applies a symmetric layout with porches surrounding the building (Sumalyo, 1993). The symmetric floor plan divides private areas (bedrooms) in the south and the semipublic area (family room) in the north. In addition, porches appear in four places at the front and side (no. 1 and 5) and two porches at the rear parts (no. 6 and 10) as shown in Figure 6 below:

At the front porch, the adaptation to the new function can be seen in the addition of a trellis on the front windows for security. Apart from that, a non-permanent ramp was added for wheelchair and gurney access because this path is also used as an emergency exit (as seen in Figure 8 below).

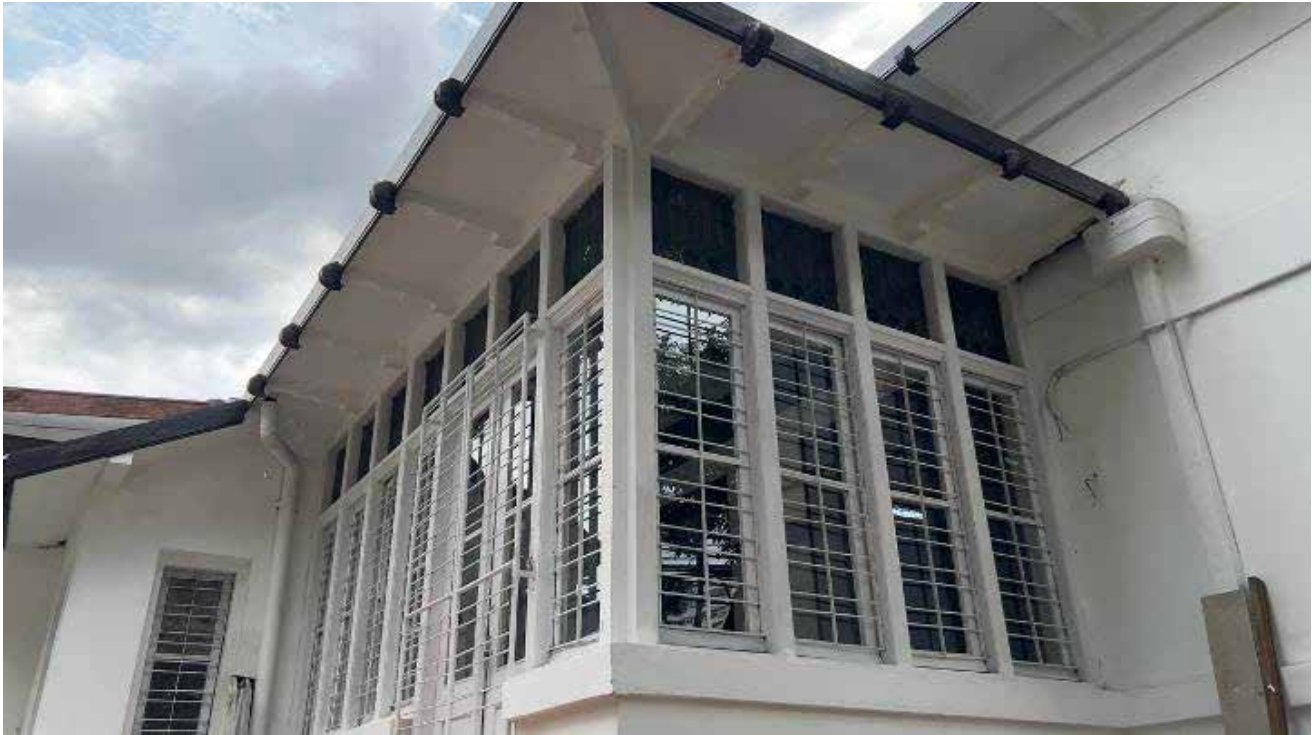
Figure 9: Current rear porch condition (source: Survey, 2024)

This condition is different from the two porches (side and rear numbers 6 and 7), which are no longer functioning. Another part of the building (number 10) is occupied by another owner and became part of the house at the back. Meanwhile, the other rear porch (number 7) is closed and used as the office of the head of the CHC. The door and the windows are permanently closed, but this room still receives morning sunlight from the east (see Figure 9). Apart from that, the doors and windows in rear porch number 7 are closed by a trellis for security because the backyard is occupied by another owner and used as a coffee shop.

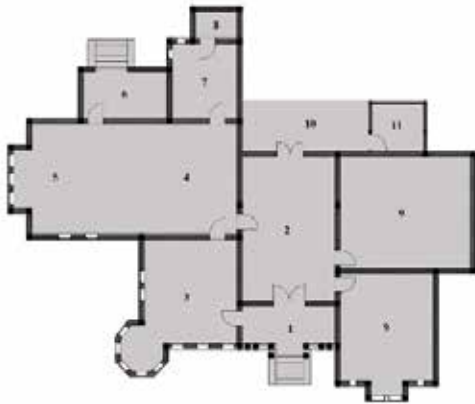
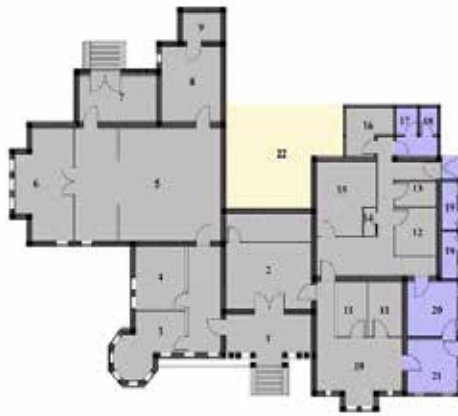
Table 2 Changes to the building layout (Source: Survey, 2024)

1	Foyer	1	Waiting room
2	Sitting room	2	Registration room
3	Study room	3	Emergency room
4	Living & dining room	4	General treatment
5	Side porch	5	Administration room
6 & 10	Rear porch	6	Administrative head office
7	Kitchen	7	Head of the health center's office
8	Toilet	8	Pantry, locker, and prayer room
9	Sleeping room	9	Staff toilet
11	Toilet	10	Pharmaceutical room
		11	Counseling room
		12	Pediatrics
		13	Equipment and medicine storage
		14	Lactation room
		15	Obstetrics and immunization
		16	Storage
		17	Sterilization room
		18	Public toilet
		19	Laboratory
		20	Waiting room for dental clinic
		21	Dental clinic
		22	Occupied by another owner

The building now provides various clinics, such as dental, pediatric, and obstetrics, equipped with an emergency unit, laboratory, pharmacy, and administration. The former residency building could not meet the needs of these “complex” rooms, so the former bedrooms and study rooms were eventually divided into smaller rooms using semi-permanent gypsum partitions. The overall changes in the building layout can be seen in Table 2 above. The implications of these actions are (1) they created a narrow alley (90 cm) as access to some rooms, which does not qualify as a public building; (2) nonpermanent access to the emergency unit for wheelchairs and gurneys; (3) the administration room used is also used as a passageway to another room (rooms 6,7,8, and 9); (4) room number 8 is more like a multifunction

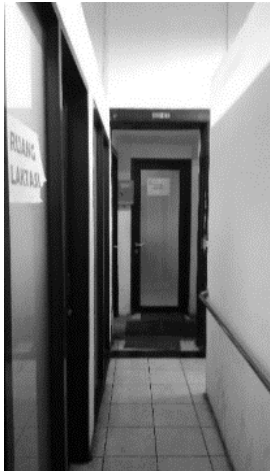
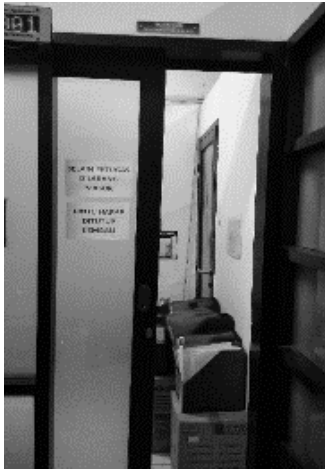
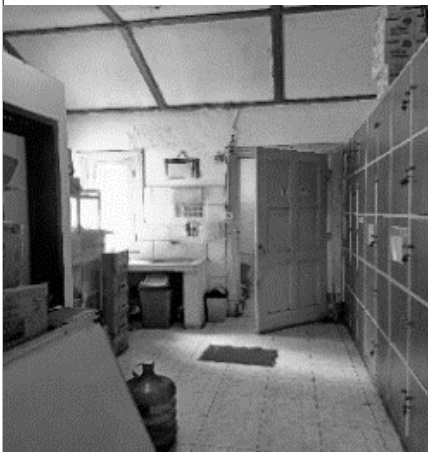
Narrow access to the lactation room (14)	Narrow access to the general treatment room (4)	The multifunction room is used as a pantry, locker, prayer room, and access to the staff toilet (8)

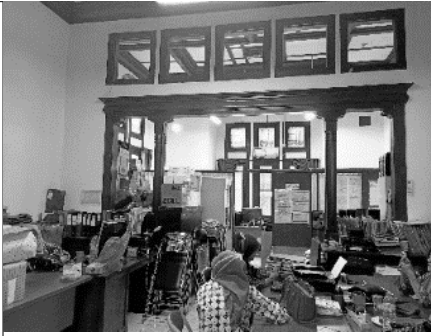
The living and dining room was transformed into an administration room, which also accesses other rooms (5)

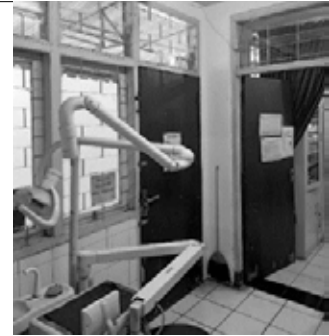
The dental clinic in the additional building (21)

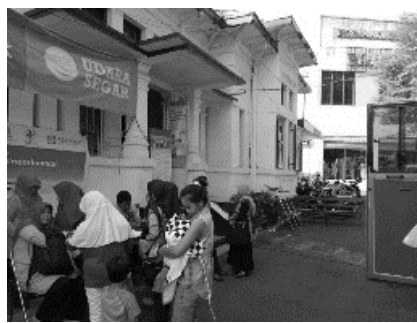
The front yard was used as a waiting room

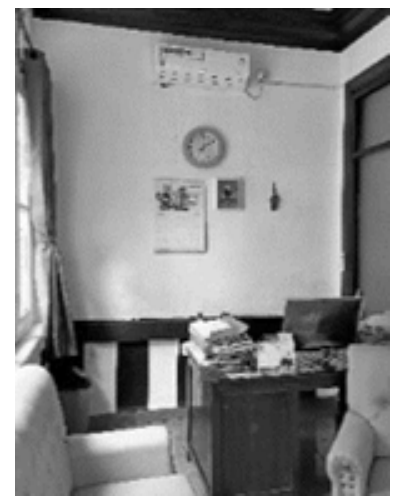
The rear porch was transformed into the administrative head's office (6)
